DC-10

SERVICE BULLETIN

Bulletin 25-163

EQUIPMENT/FURNISHINGS - Passenger Compartment - Modify Partition Vertically Mounted Emergency Oxygen Boxes.

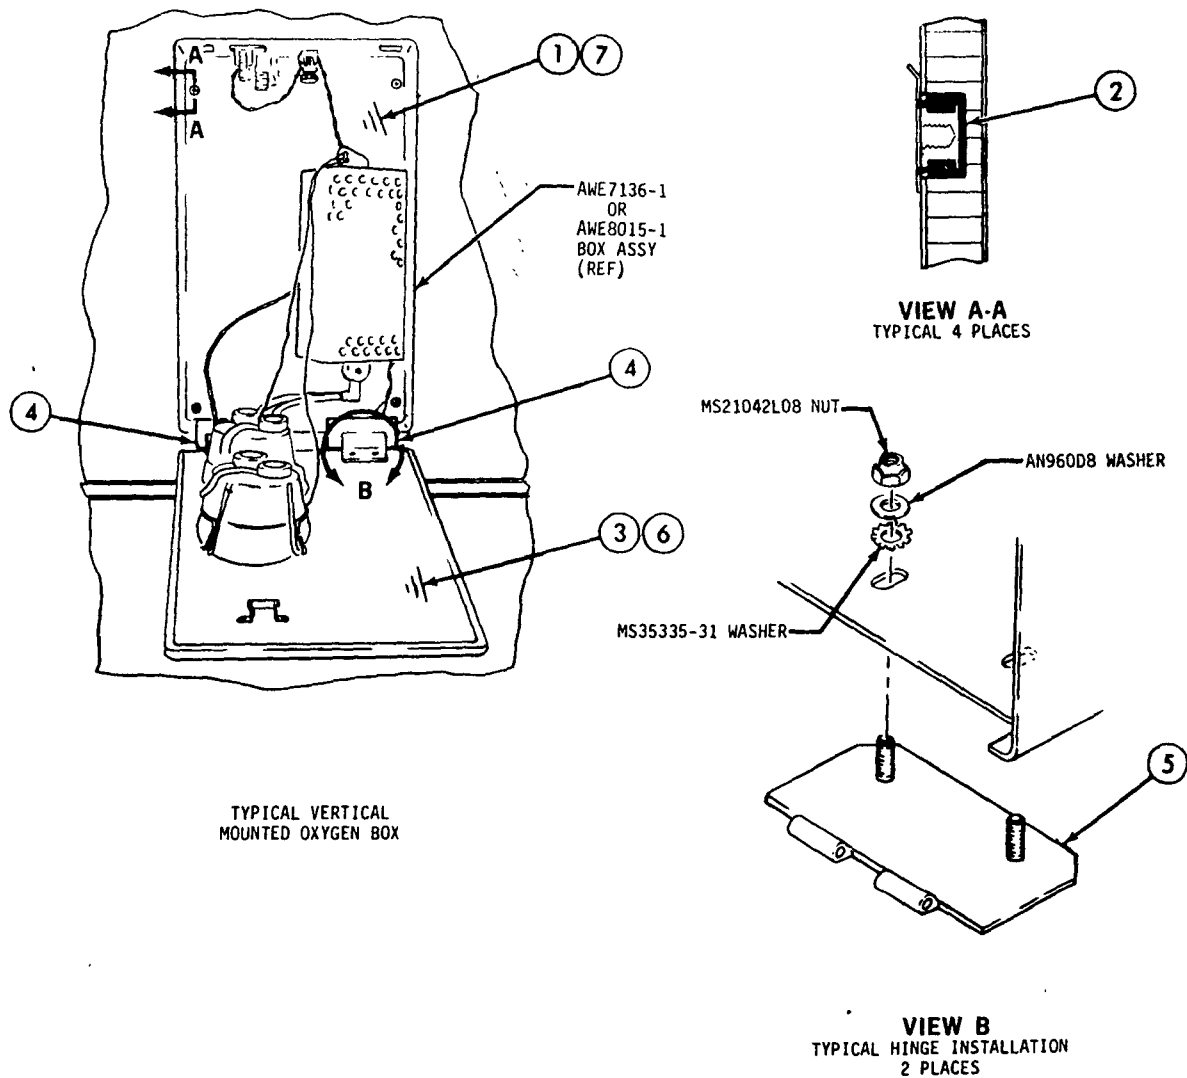
VERTICALLY MOUNTED OXYGEN BOX - MODIFICATION

One operator and DAC personnel have reported instances of the vertically mounted passenger emergency oxygen doors not dropping through the full 180-degree deployment. This condition is attributed to difficulty in achieving proper door hinge adjustment. If not modified, the door may not fully deploy, restricting the passage space between the partition and passenger seating. Replacing the oxygen box hinges with hinges that permit adjustment of the door without removal of the box assembly from the partition cavity, will facilitate adjustment and ensure full 180-degree deployment of door.

- ① REMOVE AND RETAIN EMERGENCY OXYGEN BOX ASSEMBLY FROM PARTITION RECESS. DISCARD ATTACHING PARTS.
- ② INSTALL FOUR SL607-08-75 INSERTS IN PARTITION AS FOLLOWS:
 - a. DRILL OUT FOUR EXISTING HOLES IN PARTITION TO .453/.458-INCH DIAMETER TO A MINIMUM DEPTH OF .397 INCH.
 - b. INSTALL INSERTS USING SLE3009 CASTING COMPOUND. (SEE DOUGLAS PROCESS STANDARD 1.902, TYPE 2.)
- ③ REMOVE DOOR FROM OXYGEN BOX ASSEMBLY. RETAIN HINGE PINS.
- ④ REMOVE TWO AWE7133-11 HINGES AND ATTACHING PARTS.
- ⑤ INSTALL TWO AWE7133-13 HINGES USING FOUR MS35335-31 WASHERS, AN960D8 WASHERS, AND MS21042L08 NUTS.
- ⑥ INSTALL DOOR ON OXYGEN BOX ASSEMBLY USING RETAINED HINGE PINS.
- ⑦ INSTALL OXYGEN BOX ASSEMBLY IN PARTITION RECESS USING FOUR AN960D8 WASHERS AND NAS5302-6 SCREWS.
